**Flood Control Project Maintenance
Levee Inspections**

Maintenance Issue Types Only, Levee Inspection Report By Mile - Spring 2019

Sutter Maintenance Yard Maintenance Area 0013

Waterway	Bank	Unit Miles	Inspection Start/End	Inspector
Unit No. 01 Cherokee Canal	Right	18.19	05/15/2019 05/15/2019	Makar Sokol

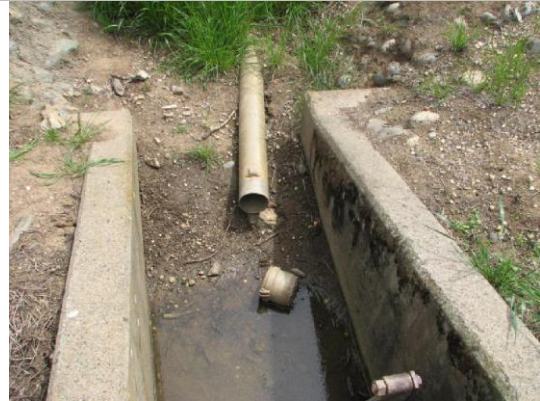
Photo 3 of 3 : UCIP_SP_2019_52180_66687.jpg

Comment Code					
Inspector Comment					
FS_ID:52180 DS_ID:16343 EP_NO: N/A Repair Type: No Action Needed Crossing Status: Found UCIP Comments: 6/14/2017 Crossing appears to be in good condition. Pipe has been selected to be internally cleaned and inspected as part of the DMP project. (DWR Sutter Yard- AFreitag)11/16/2016 Crossing appears to be in good condition. (DWR Sutter Yard- AFreitag)4/28/2016 Crossing appears to be in good condition. 7/14/2015 Crossing appears in good condition. No noticeable issues to report.5/21/2014 Same as last inspection. 12/2/2013 Same as last inspection. 7/10/2013 Same as last inspection. 4/17/2012 Drain is still in use. 4 inch pipe in channel near WS headwall (see photo). The pipe does not appear to impact the crossing. FIELD_STRUCT_DESC: 24-inch corrugated metal drainage pipe through the levee, 8.6 feet below the crown. Concrete "U" headwalls on both the waterside (WS) and landside (LS). Flap gate on the WS end. [Additional Reference(s): DWR Levee Log, 1993. USACE Sacramento O&M Manual 519, June 1962 (HLM 1.15)] FS Date: 6/16/2017 10:11:43 AM

View of WS with pipe in channel.

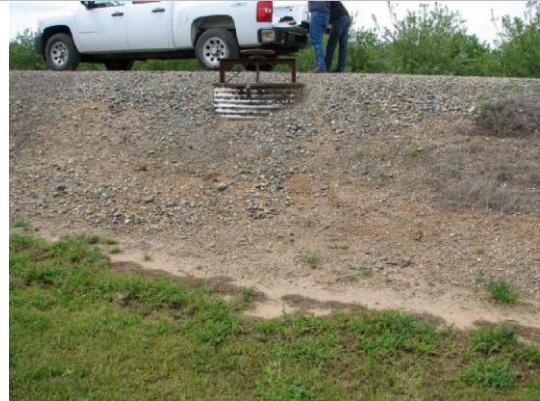
Photo 2 of 3 : UCIP_SP_2019_52938_66699.jpg

FS_ID:52938
DS_ID:16831
EP_NO: N/A
Repair Type: Non-Urgent
Crossing Status: Found
UCIP Comments: 8/23/2018 Same as last inspection; still no sign of WS pipe end. Unclear if this SD crossing is still in use. The WS toe has standing, mucky, water around where the pipe end should be. Downgrading to Non-Urgent from Urgent because there appears no immediate threat to levee. Recommend follow up with owner to determine pipe use, and an internal pipe inspection to determine pipe integrity and threat to levee (D. Sanoski - DWR UCIP).6/14/2017 Still no sign of WS pipe end. Pipe may need to be traced with GPR and excavated to determine if the WS end was properly capped after the Headwall and pipe sections were removed. Pipe has been selected to be internally cleaned and inspected as part of the DMP project. (DWR Sutter Yard- AFreitag)11/16/2016 WS structures still removed. (DWR Sutter Yard- AFreitag)10/17/2016 Landowner removed WS concrete headwall and pipe section through floodway to make room for orchard. The area disturbed appears to be from WS toe to where the mature trees are located within floodway, approximately 45 feet from WS toe. Crossing is classified as Urgent with potential levee integrity issues due to the disturbance of the WS without prior approval from the CVFPB. (DWR UCIP - omagana)

4/28/2016 Landowner appears to have removed the WS headwall and pipe to make room for planting more orchard trees. LS pipe end was full of water as it has no where to drain to anymore. Changing to urgent listing but it currently does not affect the levee integrity. (see photos 8, 9, & 10) (DWR Sutter Yard - afreitag)7/14/2015 Crossing appears in good condition. No noticeable issues to report. (DWR Sutter Yard - afreitag)5/21/2014 Same as last inspection. (DWR Sutter Yard - afreitag)12/2/2013 Pipe section was dug up and repaired. Crossing is now in good condition. (DWR Sutter Yard - afreitag) 4/17/2012 Pipe collapse on WS 10 feet from toe, needs repair. From WS, sediment is visible inside pipe. (DWR UCIP - omagana)
FIELD_STRUCT_DESC: 36-inch corrugated metal drainage pipe through the levee, 7.8 feet below the crown. Concrete "U" headwalls on both waterside (WS) and landside (LS) ends. Slide gate in corrugated metal pipe (CMP) riser on the WS slope. [Additional Reference(s): DWR Levee Log, 1993. USACE Sacramento O&M Manual 519, June 1962 (HLM 1.62)]

Corrugated metal riser with slide gate located on WS slope.

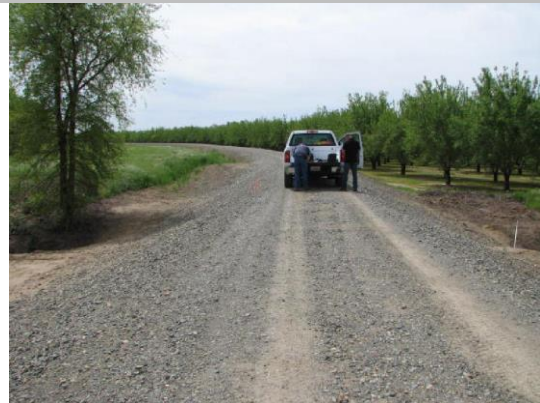
Photo 1 of 3 : UCIP_SP_2019_52185_66715.jpg

Comment Code					
Inspector Comment					
FS_ID:52185 DS_ID:16347 EP_NO: N/A Repair Type: No Action Needed Crossing Status: Found UCIP Comments: 6/14/2017 Crossing appears to be in good condition. (DWR Sutter Yard- A/Freitag)11/16/2016 Crossing appears to be in good condition. (DWR Sutter Yard- A/Freitag)4/28/2016 Crossing appears to be in good condition.7/14/2015 Crossing appears in good condition. No noticeable issues to report.5/21/2014 Same as last inspection.12/2/2013 Same as last inspection.7/15/2013 Same as last inspection.4/17/2012 Vegetation/sedimentation from WS has been removed. This crossing was listed in the USACE Periodic Inspection report as Corp's inspect ID#USACE_CESPK_M13D_2011_p_0130 for WS flap gate closed and blocked by sediment. FIELD_STRUCT_DESC: 24-inch corrugated metal drainage pipe through the levee, 9.4 feet below the crown. Concrete "U" headwall on both waterside (WS) and landside (LS) ends. Flap gate on the WS end. [Additional Reference(s): DWR Levee Log, 1993. USACE Sacramento O&M Manual 519, June 1962 (HLM 2.74)] FS Date: 6/16/2017 12:27:02 PM

Overview of levee crown looking downstream at crossing.

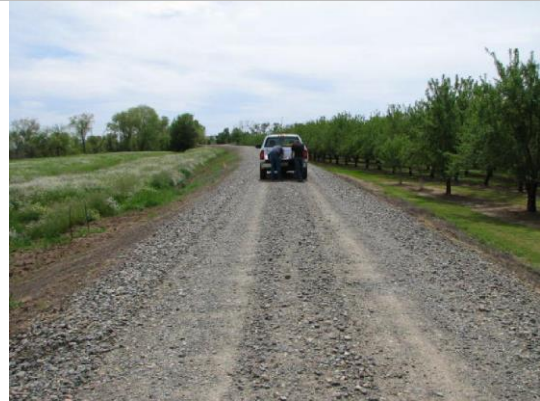
Photo 1 of 3 : UCIP_SP_2019_52186_66718.jpg

FS_ID:52186
DS_ID:17372
EP_NO: N/A
Repair Type: Non-Urgent
Crossing Status: Found
UCIP Comments: 6/14/2017 WS flap gate is completely buried by sediment- needs to be dug out. Pipe is about 50% full of sediment inside. Pipe has been selected to be internally cleaned and inspected as part of the DMP project. (DWR Sutter Yard- AFreitag)11/16/2016 Pipe about 50% full of sediment. (DWR Sutter Yard- AFreitag)4/28/2016 Pipe on LS is about 50% full of sediment. There is now a concrete pipe that discharges into the LS inlet of this crossing. Not sure where the concrete pipe comes from.7/14/2015 Crossing appears in good condition. No noticeable issues to report.5/21/2014 Same as last inspection.12/2/2013 Pipe section was dug up and repaired. Crossing is now in good condition.7/15/2013 Pipe appears to have a possible hole in top of pipe about 10ft. in from LS headwall.4/17/2012 LS headwall blocked by sediment (50 % of opening is covered). LS floor is higher than LS pipe invert. WS headwall has been recently cleared of vegetation and sediment. This crossing was listed in the USACE Periodic Inspection report as Corp's inspect ID#USACE_CESPK_M13D_2011_p_0157 for WS and LS inlet/outlet blocked by sediment.

Overview of levee crown looking downstream at crossing.

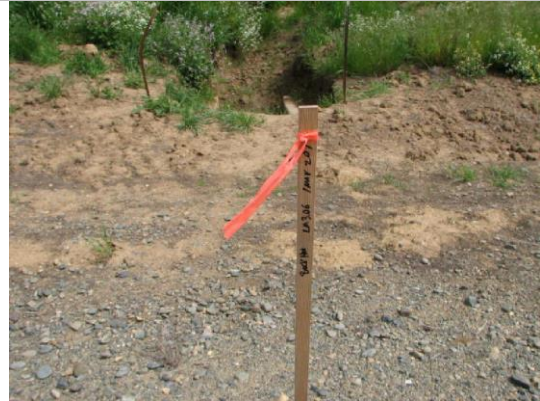
Photo 2 of 3 : UCIP_SP_2019_52186_66716.jpg

Comment Code						
Inspector Comment						
FS_ID:52186 DS_ID:17372 EP_NO: N/A Repair Type: Non-Urgent Crossing Status: Found UCIP Comments: 6/14/2017 WS flap gate is completely buried by sediment- needs to be dug out. Pipe is about 50% full of sediment inside. Pipe has been selected to be internally cleaned and inspected as part of the DMP project. (DWR Sutter Yard- AFreitag)11/16/2016 Pipe about 50% full of sediment. (DWR Sutter Yard- AFreitag)4/28/2016 Pipe on LS is about 50% full of sediment. There is now a concrete pipe that dicharges into the LS inlet of this crossing. Not sure where the concrete pipe comes from.7/14/2015 Crossing appears in good condition. No noticeable issues to report.5/21/2014 Same as last inspection.12/2/2013 Pipe section was dug up and repaired. Crossing is now in good condition.7/15/2013 Pipe appears to have a possible hole in top of pipe about 10ft. in from LS headwall.4/17/2012 LS headwall blocked by sediment (50 % of opening is covered). LS floor is higher than LS pipe invert. WS headwall has been recently cleared of vegetation and sediment. This crossing was listed in the USACE Periodic Inspection report as Corp's inspect ID#USACE_CESPK_M13D_2011_p_0157 for WS and LS inlet/outlet blocked by sediment. FIELD_STRUCT_DESC: 36-inch corrugated metal drainage pipe through the levee, 11.8 feet below the crown. Flap gate is located on the waterside (WS). Concrete headwall located on the landside (LS). [Additional Reference(s): USACE Sacramento O&M Manual 519, June 1962 (HLM 3.10)] FS Date: 6/16/2017 12:28:31 PM

WS levee slope.

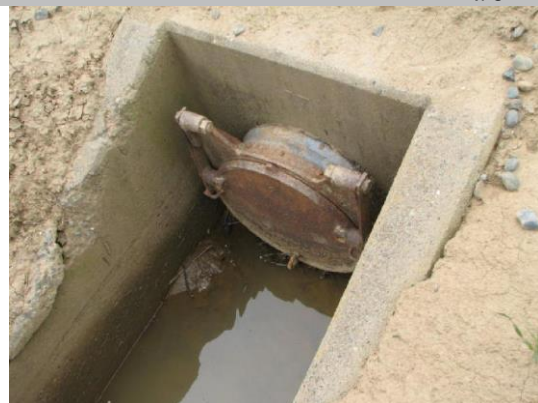
Photo 2 of 3 : UCIP_SP_2019_52188_66724.jpg

FS_ID:52188
DS_ID:16349
EP_NO: N/A
Repair Type: Non-Urgent
Crossing Status: Found
UCIP Comments: 6/14/2017 Both pipe ends and gates are mostly buried- need to be dug out. Pipe has been selected to be internally cleaned and inspected as part of the DMP project. (DWR Sutter Yard- A/Freitag)11/16/2016 Both gates closed but partially buried and unable to open. (DWR Sutter Yard- A/Freitag)4/28/2016 Sediment build up on both gates blocking them from operating properly.7/14/2015 Crossing appears in good condition. No noticeable issues to report.5/21/2014 Same as last inspection.12/2/2013 Same as last inspection.7/15/2013 Stem on LS screw gate has been replaced and is now full functional.4/17/2012 LS slide gate stem is bent and prevents gate from fully closing. Both WS and LS have been cleared of debris and sediment. This crossing was listed in the USACE Periodic Inspection report as Corp's inspect ID#USACE_CESPK_M13D_2011_p_0162 for inoperable gates on WS & LS due to sediment and grass blocking inlet and outlet.

Flap gate on WS.

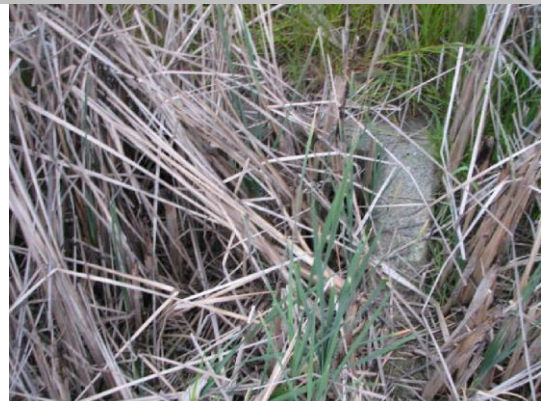
Photo 2 of 3 : UCIP_SP_2019_52191_66741.jpg

Comment Code						
Inspector Comment						
FS_ID:52191 DS_ID:16365 EP_NO: N/A Repair Type: Non-Urgent Crossing Status: Found UCIP Comments: 6/14/2017 Appears abandoned- needs to be done properly. WS gate was buried/submerged and the LS slide gate is still damaged and buried. Pipe has been selected to be internally cleaned and inspected as part of the DMP project. (DWR Sutter Yard- A/Freitag)11/16/2016 Both LS and WS gates buried. (DWR Sutter Yard- A/Freitag)4/28/2016 Abandoned crossing. Ls screw is still bent and mostly buried.7/14/2015 LS screw gate is still damaged and buried. Crossing is non-functional.5/21/2014 Same as last inspection.12/2/2013 Same as last inspection.7/15/2013 Slopes have been cleared of vegetation and are in good condition. LS screw gate is still bent and silted over.4/18/2012 LS slide gate covered with silt. Slide gate is bent. Crossing appears not be in use. Limited inspection on WS and LS slope due to dense vegetation. Need photos of cleared slopes. FIELD_STRUCT_DESC: *ABANDONED* 24-inch corrugated metal drainage pipe through the levee, 7.9 feet below the crown. Flap gate on the waterside (WS) end. Screw gate on the landside (LS) end. Concrete "U" headwalls on both ends. [Additional Reference(s): DWR Levee Log, 1993. USACE Sacramento O&M Manual 519, June 1962 (HLM 3.82)] FS Date: 6/16/2017 12:35:50 PM

WS flap gate blocked by debris.

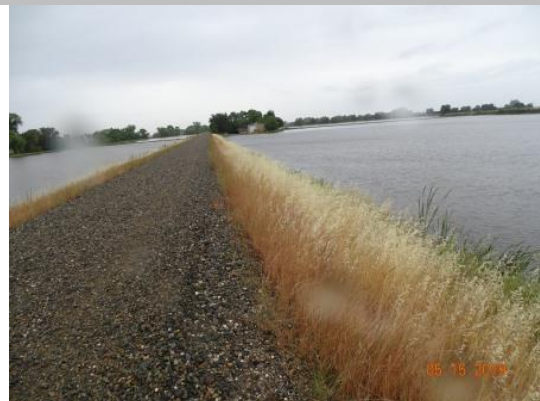
Photo 1 of 1 : SP_2019_MA0013_300_75_20190520_00145.jpg

LM Start	3.79	Rating **	U	Issue No.	75
LM End	15.81	Issue Type +	Ma	Location *	LS
Category	Earthen Levee			GPS Latitude/Longitude	
				Start	End
Item	Vegetation			39.545590 °	39.398277 °
				-121.707382 °	-121.811794 °
DWR ID	DWR_MA0013_01_s_2019_75				
Comment Code					
V1 : Control annual grass and weeds on the levee slopes and easements.					
Inspector Comment

View of the vegetation on the landside slope. Spring 2019.

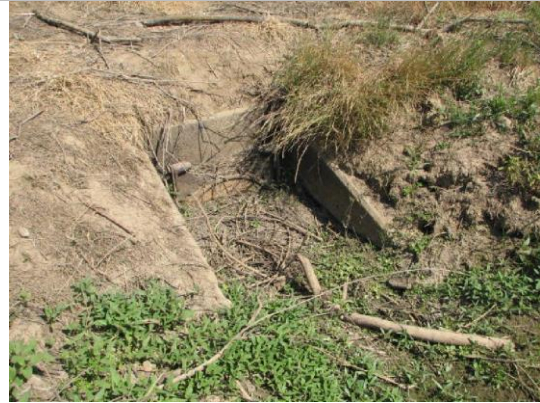
Photo 3 of 3 : UCIP_SP_2019_52201_66791.jpg

View of WS flap gate buried.

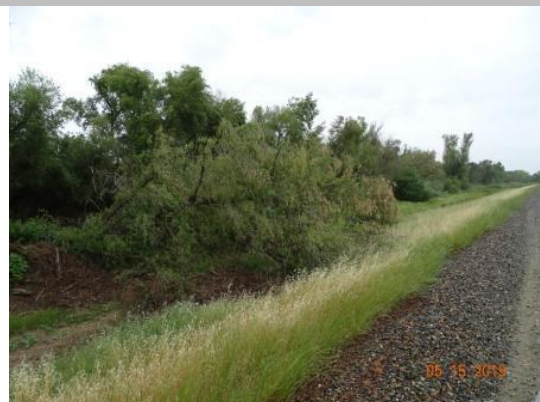
Photo 1 of 1 : SP_2019_MA0013_300_76_20190520_00146.jpg

View of the large fallen tree on the waterside slope. Spring 2019.

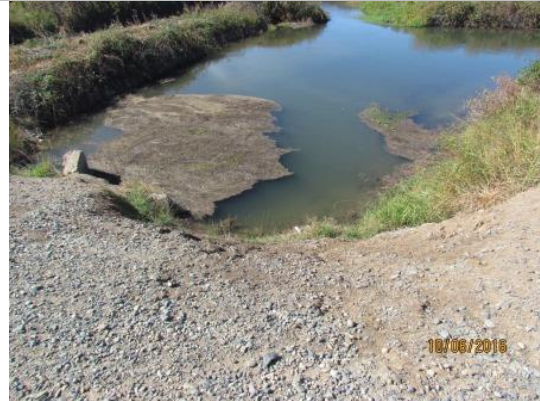
Photo 1 of 1 : SP_2019_MA0013_300_49_20190327_00006.jpg

View of the erosion site along the landside toe.

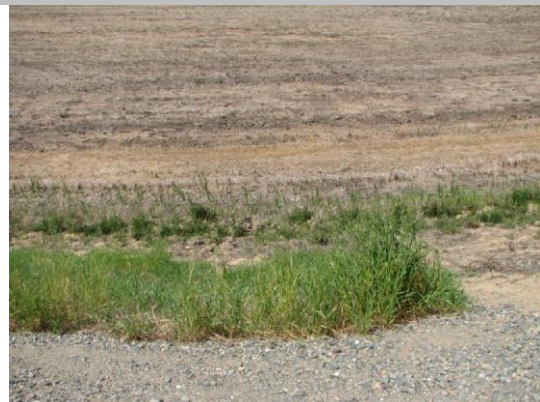
Photo 2 of 2 : UCIP_SP_2019_52240_66973.jpg

View of LS slope and toe. Unable to find welded plate on LS.

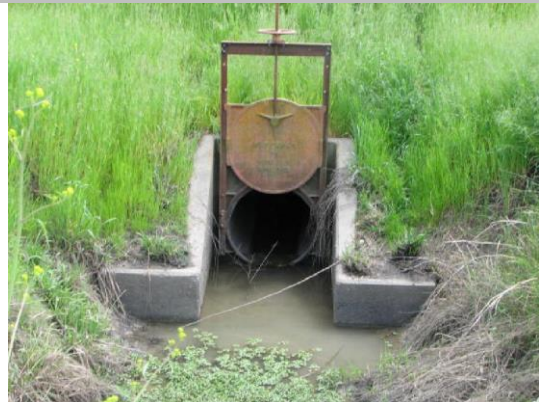
Photo 2 of 3 : UCIP_SP_2019_52242_66980.jpg

Slide gate located on LS toe. Dense vegetation present on LS slope.

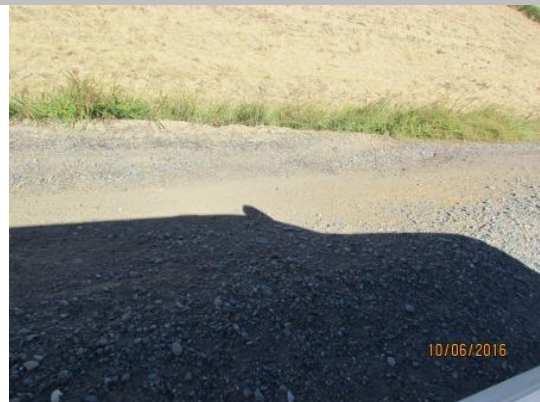
Photo 1 of 1 : SP_2019_MA0013_300_57_20190327_00008.jpg

View of slope instability along the landside slope.

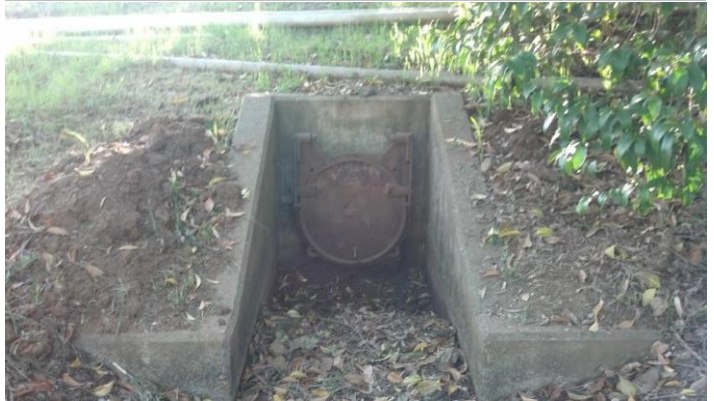
Photo 2 of 3 : UCIP_SP_2019_52111_45642.jpg

Headwall and flap gate on WS. Soil and pipes stockpiled next to headwall.

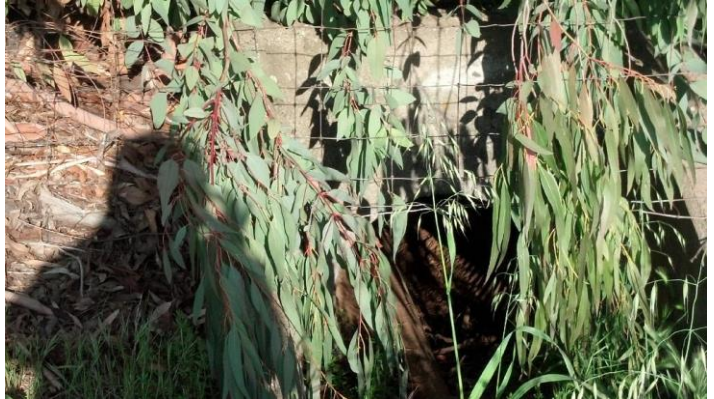
Photo 3 of 3 : UCIP_SP_2019_52111_45643.jpg

LS headwall blocked by overgrown branches.

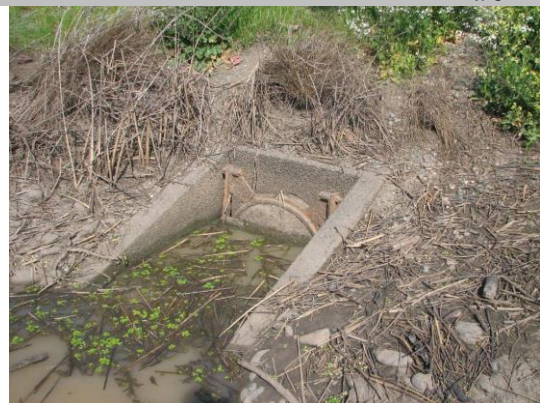
Photo 2 of 3 : UCIP_SP_2019_52124_67116.jpg

Unable to determine condition of flap gate on WS due to high water.

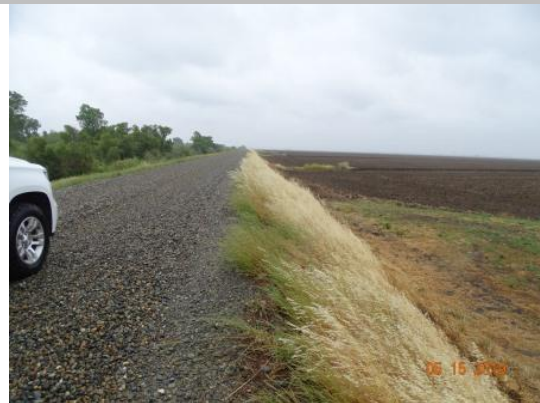
Photo 1 of 1 : SP_2019_MA0013_301_72_20190520_00132.jpg

View of the vegetation on the landside slope. Spring 2019.

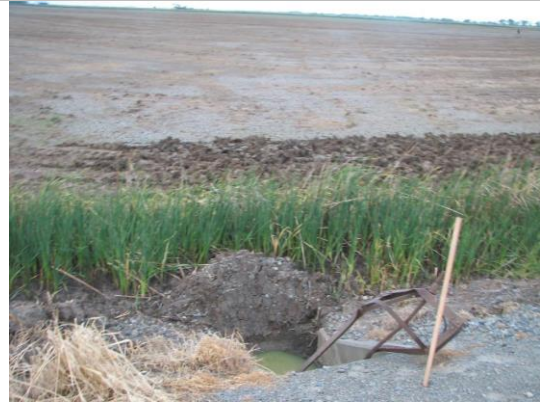
Photo 3 of 3 : UCIP_SP_2019_52129_67141.jpg

Overview of LS floor is higher in elevation than pipe invert causing build up sediment.

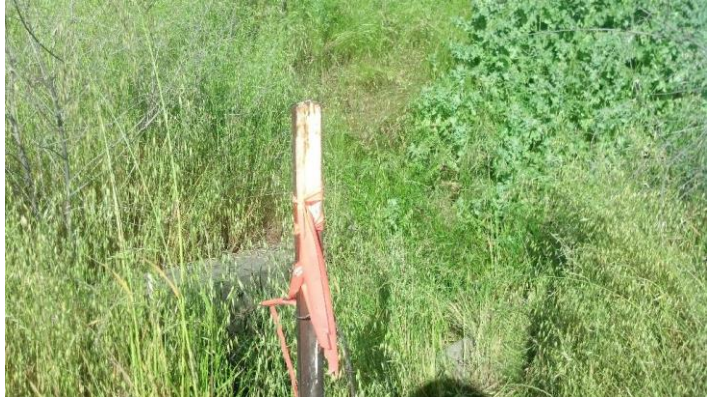
Photo 2 of 3 : UCIP_SP_2019_52156_67343.jpg

Dense vegetation covering the majority of the WS. WS headwall difficult to see through dense vegetation.

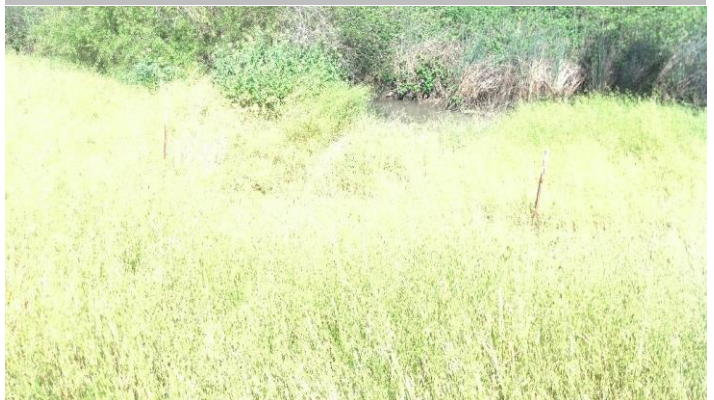
Photo 2 of 3 : UCIP_SP_2019_52157_67351.jpg

View of WS slope. Limited inspection due to the dense vegetation.

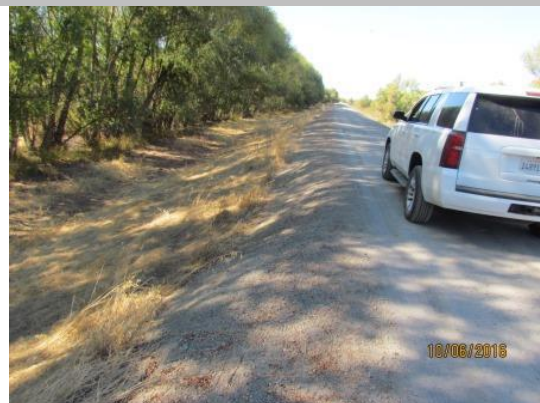
Photo 1 of 1 : SP_2019_MA0013_301_62_20190327_00012.jpg

View of slope instability issue along the landside slope.

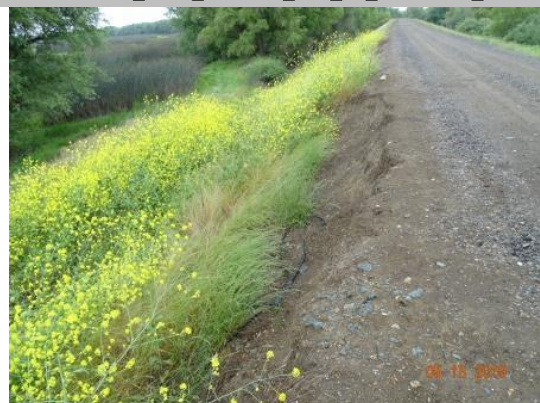
Photo 1 of 1 : SP_2019_MA0013_301_61_20190520_00134.jpg

View of the erosion at the landside shoulder and slope. Spring 2019.
